DOT/FAA/AR-95/13

Structural Integrity Evaluation of the Lear Fan 2100 Aircraft

May 1996

Final Report

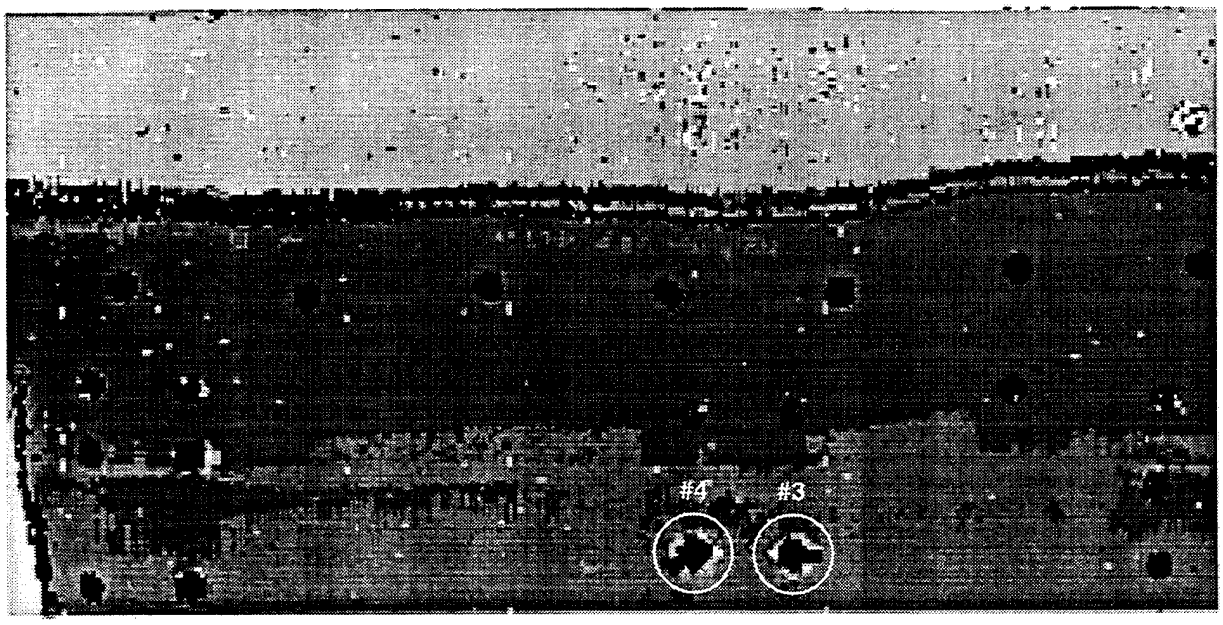
F95-HPK/02

FIGURE 5. MAUS IMAGES OF DEFECT NOS. 3 AND 4 ON THE UPPER LEFT WING SKIN.

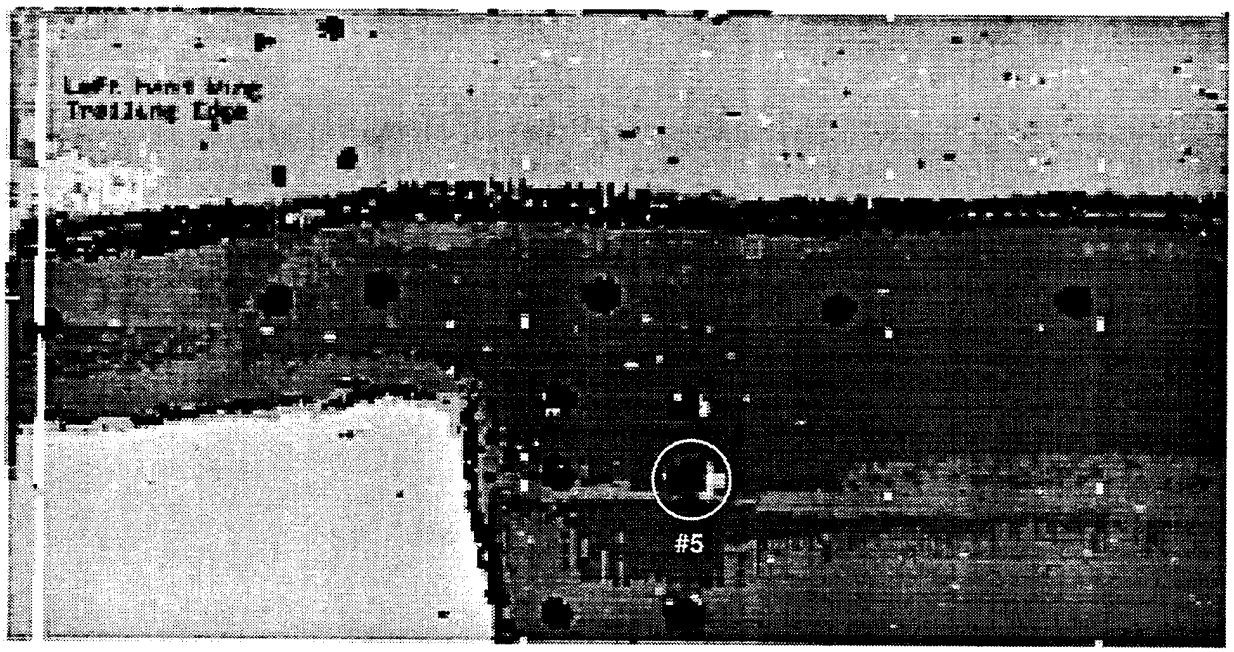
F95-HPK/03

FIGURE 6. MAUS IMAGE OF DEFECT NO. 5 ON THE UPPER LEFT WING SKIN.

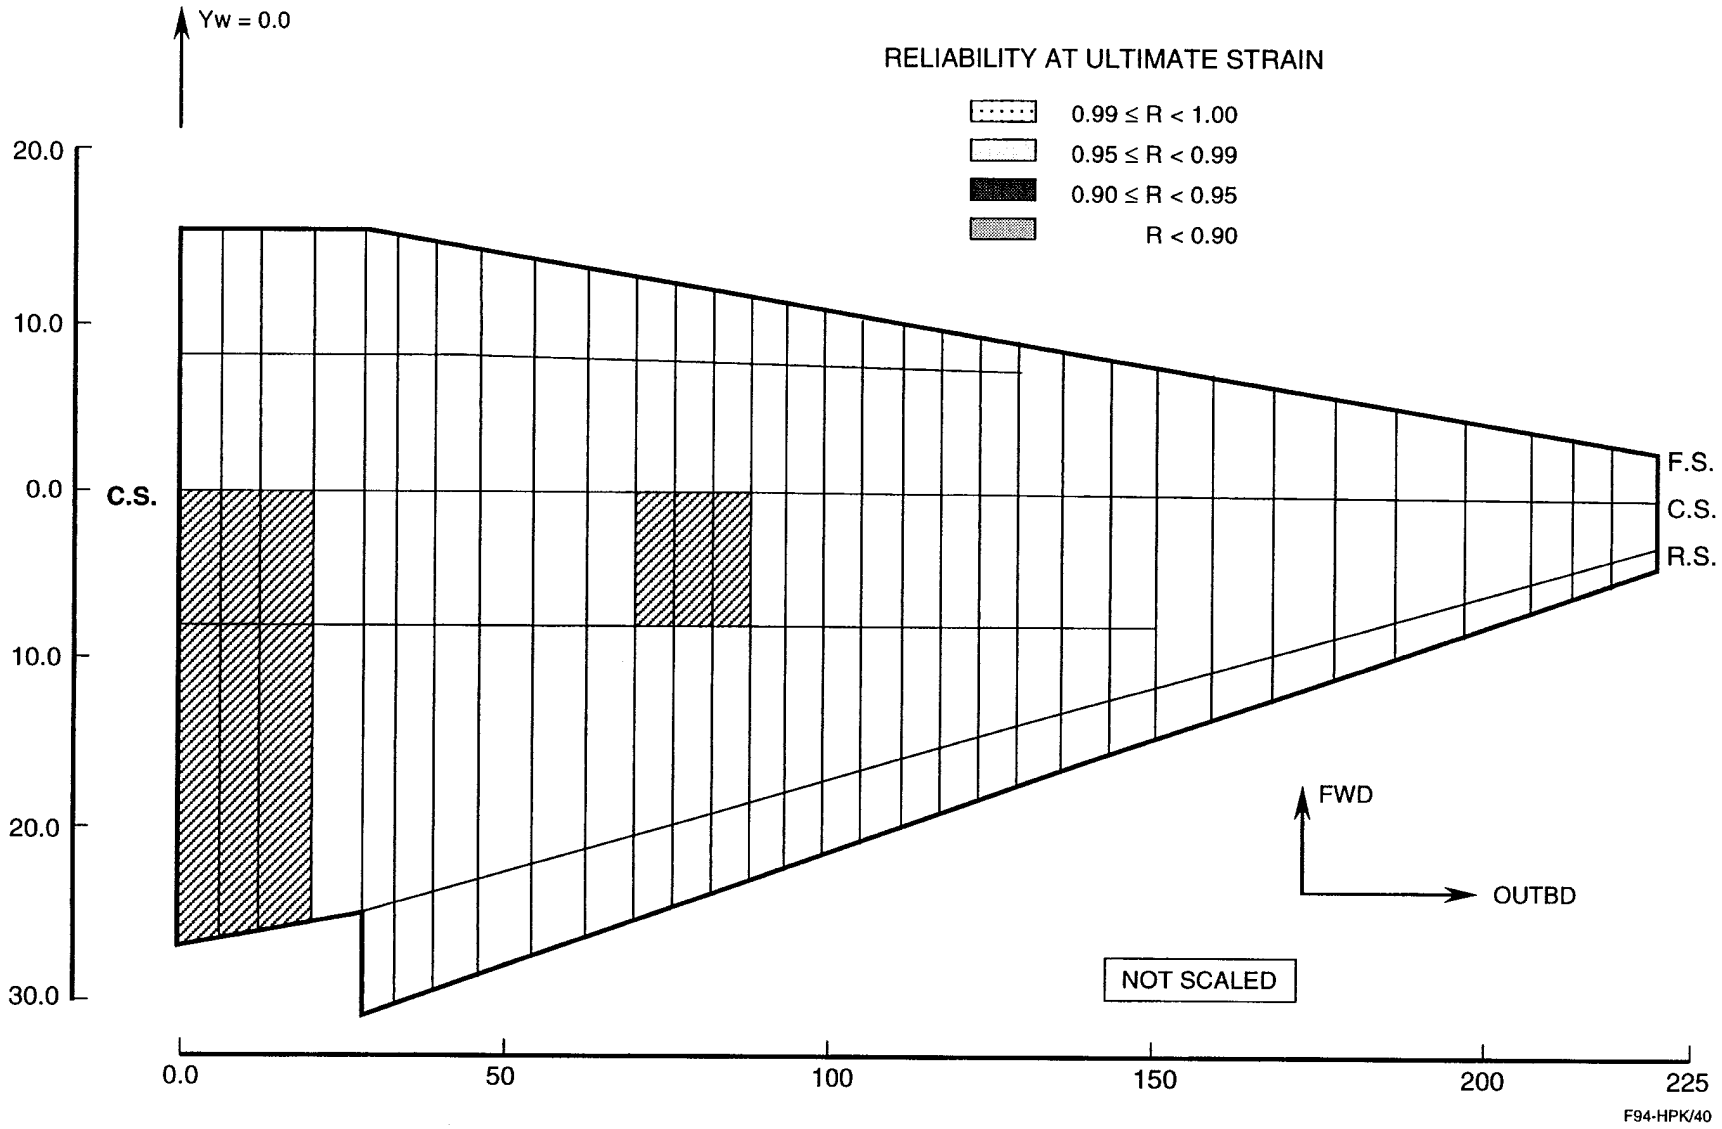
FIGURE 35. CRITICAL IMPACT DAMAGE LOCATIONS OF THE UPPER WING SKIN.

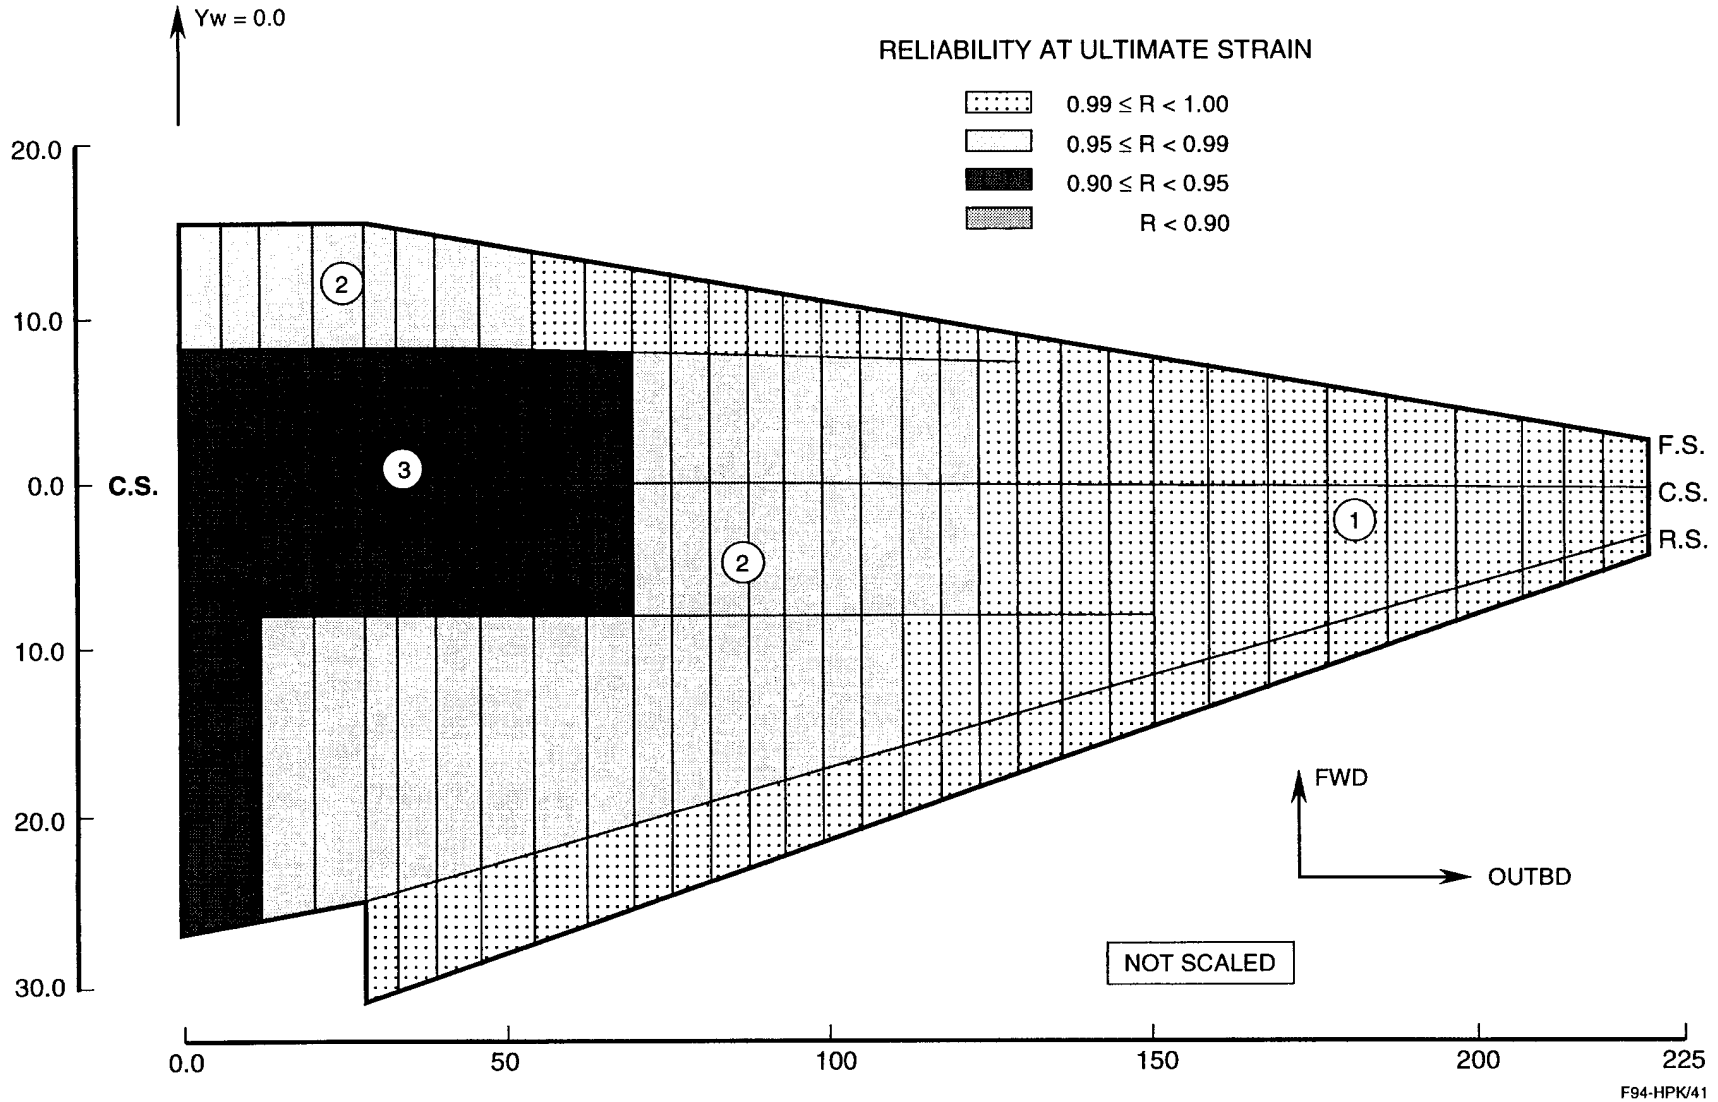
FIGURE 36. RELIABILITY OF UPPER WING SKIN WITH 2.0-IN.-DIAMETER ASSEMBLY INDUCED DAMAGE, S_r = 0.15, MAXIMUM STRAIN.

The minimum reliabilities at limit and 1.25 times limit strains exceed 0.99 and the minimum reliability at ultimate strain is 0.92825. Figure 36 shows the reliability distribution within the upper wing skin with 2.0-in.-diameter assembly induced damage under maximum ultimate strain. The figure shows that the reliability exceeds 0.90 for the entire wing skin. These results indicate that the baseline assembly induced damage is less severe as compared to the impact threats.

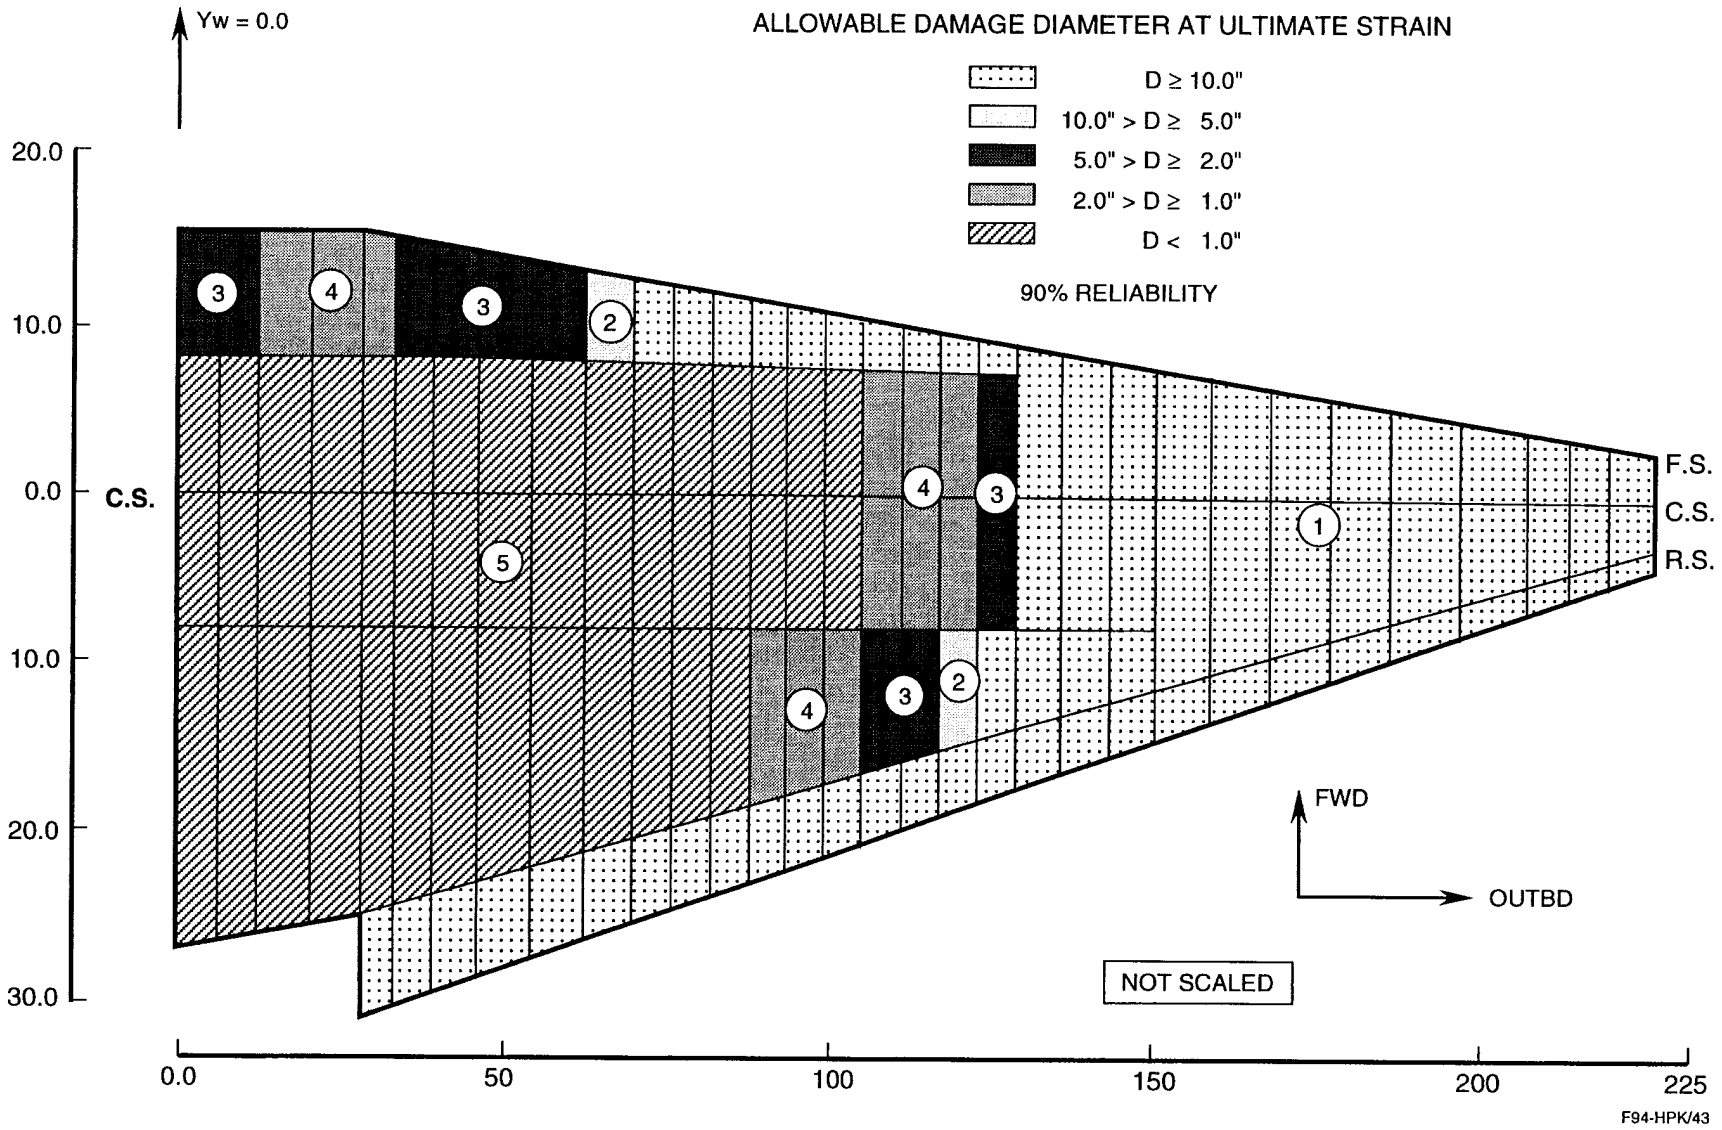
Similar results for reduced stiffness retention ratio are summarized in tables 13 and 14 and are shown in figures 38 and 39. Table 13 shows the results for a stiffness retention ratio (Sr) of 0.01. This level of damage is usually induced by a poor assembly process due to severe overtorque or fastening composite parts with large unshimmed gaps. The results shown in table 13 indicate that the minimum allowable damage diameter is approximately 0.4 in. for the 0.90 reliability requirement in the most critical area of the wing skin. For a 0.99 reliability requirement, no damage of this type will be tolerated in the critical area, as the minimum allowable damage diameter is smaller than the fastener hole diameter of 0.25-in. The distribution of the allowable damage size is shown in figure 38. This figure shows that the allowable damage

FIGURE 38. ALLOWABLE ASSEMBLY INDUCED DAMAGE DIAMETER IN THE UPPER WING SKIN, 90% RELIABILITY, S_r = 0.01, MAXIMUM STRAIN.

size is still large in the wing tip area. However, the allowable damage diameter is smaller than 2.0-in. for a large portion of the skin inboard of Yw 123.

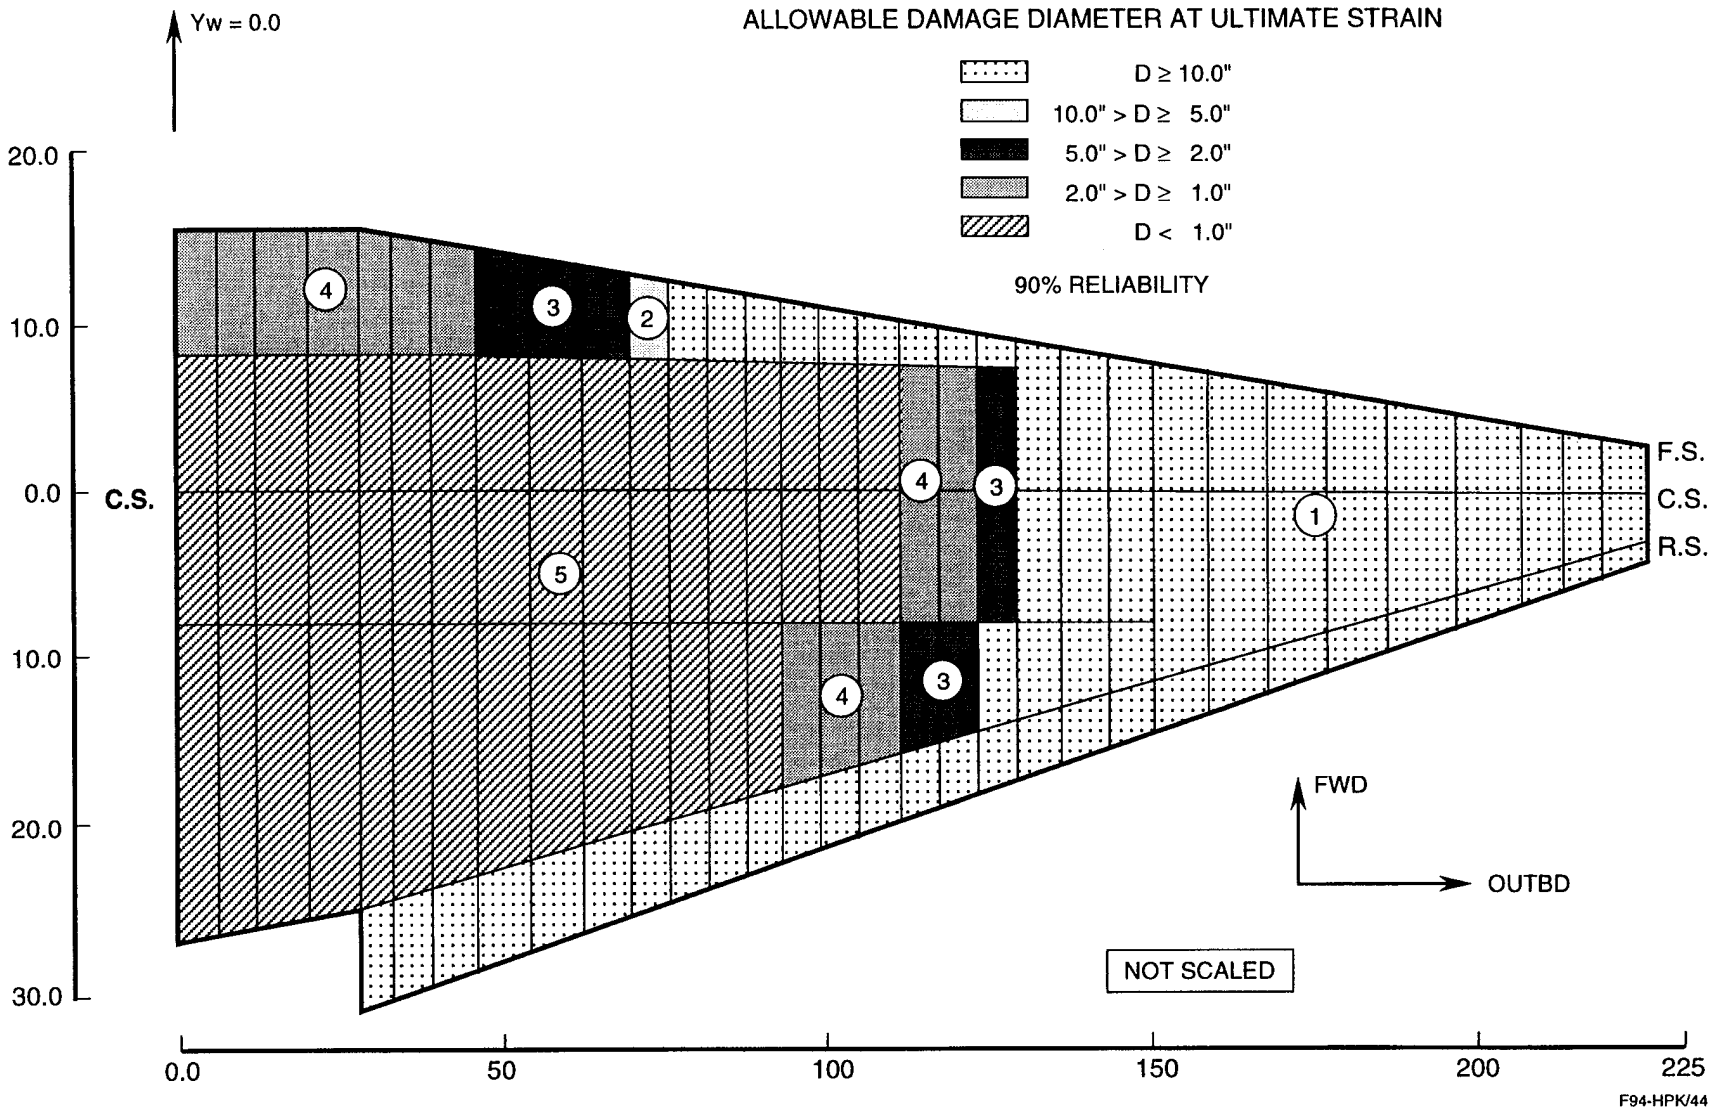
FIGURE 39. ALLOWABLE ASSEMBLY INDUCED DAMAGE SIZE IN THE UPPER WING SKIN, 90% RELIABILITY, S_r = 0.001, MAXIMUM STRAIN.

Table 14 shows results for Sr=0.001, which represents damage induced by a very poor assembly procedure with nearly visible fastener pull-through. As expected, the results show a very significant reduction in the allowable damage size in the critical locations of the wing skin. The minimum allowable damage diameter for a 0.90 reliability, is 0.375-in. in subdivisions 137 and 138. The 0.90 reliability damage size distribution is shown in figure 39. As shown in the figure, the allowable damage diameter is smaller than 1.0 in. for a large portion of the skin inboard of Yw 111.

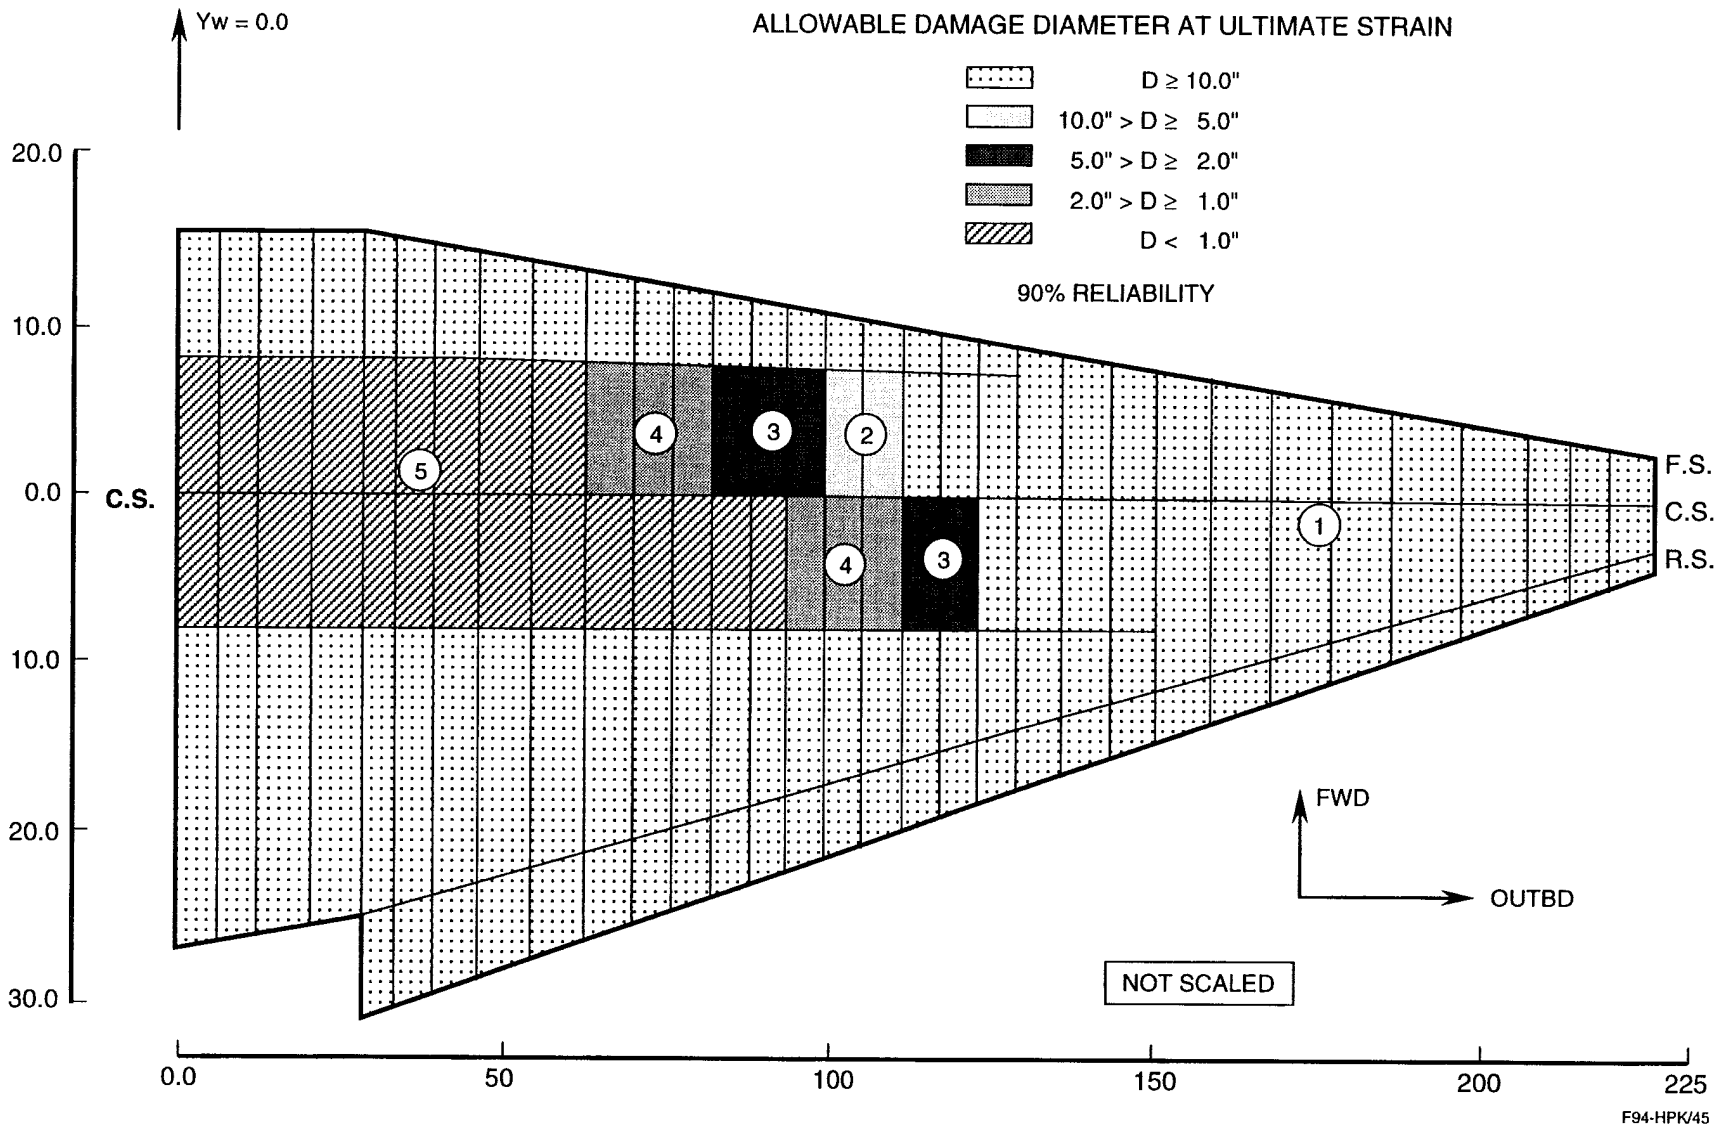
Table 15 and figure 40 show the results of allowable damage size for the wing skin under average ultimate strain in each subdivision with Sr=0.01, for comparison purposes. These results show that a large portion of the skin is capable of tolerating large size damage. However, the allowable damage diameter is smaller than 1.0 in. for portions of the inboard area near the center spar.

FIGURE 40. ALLOWABLE ASSEMBLY INDUCED DAMAGE SIZE IN THE UPPER WING SKIN, 90% RELIABILITY, S_r = 0.01, AVERAGE STRAIN.

The results of the assembly induced damage tolerance evaluation for the Lear Fan 2100 upper wing skin show that the structure is capable of tolerating damage induced by normal assembly operation. This is evident by the defects detected on the E009 aircraft. However, NDI after final assembly is needed to assure that the structures are properly assembled, because the results of the evaluation indicate that poor assembly operation may degrade the integrity of the
